H/Z-100 Field Service Bulletins

Z-100 Field Service Bulletins

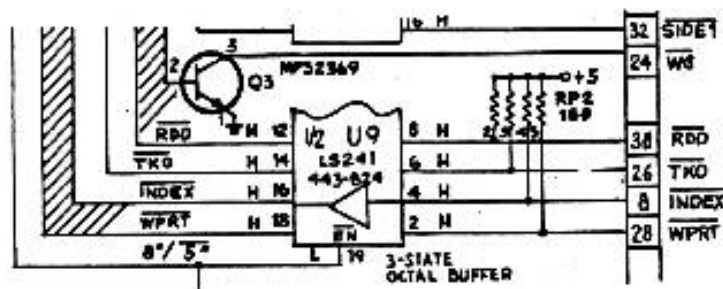
- Z207 Schematic

Locate the lower portion of U9 (near the 5" interface connector) and change the buffer symbol as follows:

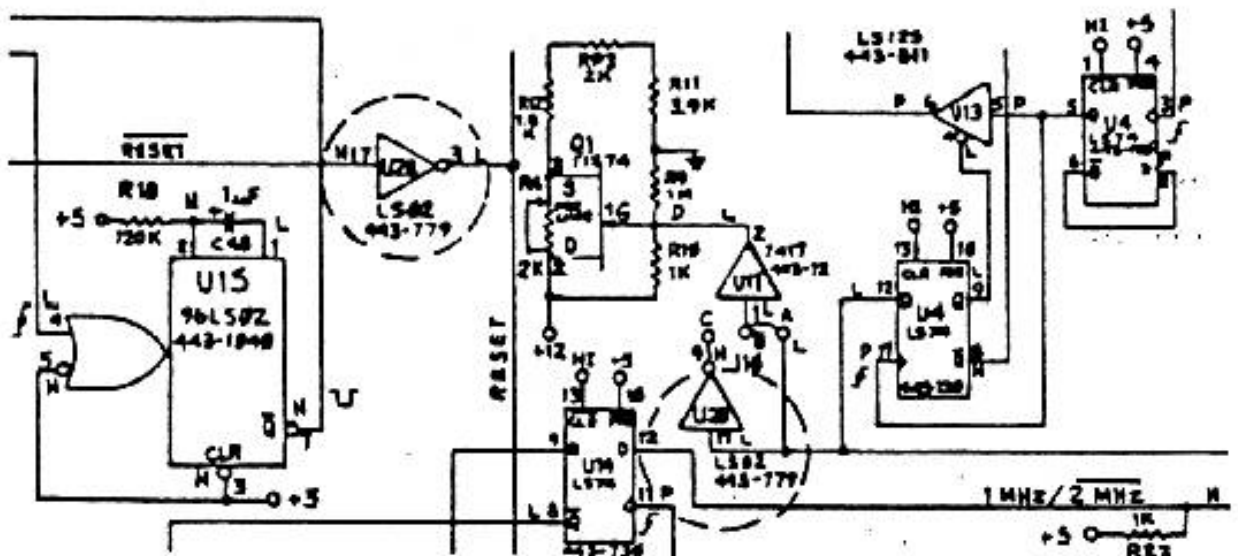
- Page 3-104: In the second & third paragraphs, cross out "video board" and write in "motherboard."
- Page 3-120: Fifth step from the bottom, change "U152-13 = L" to "U152-13 = P."
- Schematic MB3: Locate U170; this is a dual 4-input NAND gate in the refresh timing and the wait timing circuits. Cross out "ALS40" and replace it with "ALS1020."
- Z-207 Floppy Disk Controller Schematic:
 - Locate the INTROQ line at U22-39 and trace it left to U25-3 (next to RP3-2). Change U25-3 to U25-13.
 - Locate the two inverter sections labeled "U28" beside "U15" and "U14" on your schematic (see the following figure) and change to "U10."

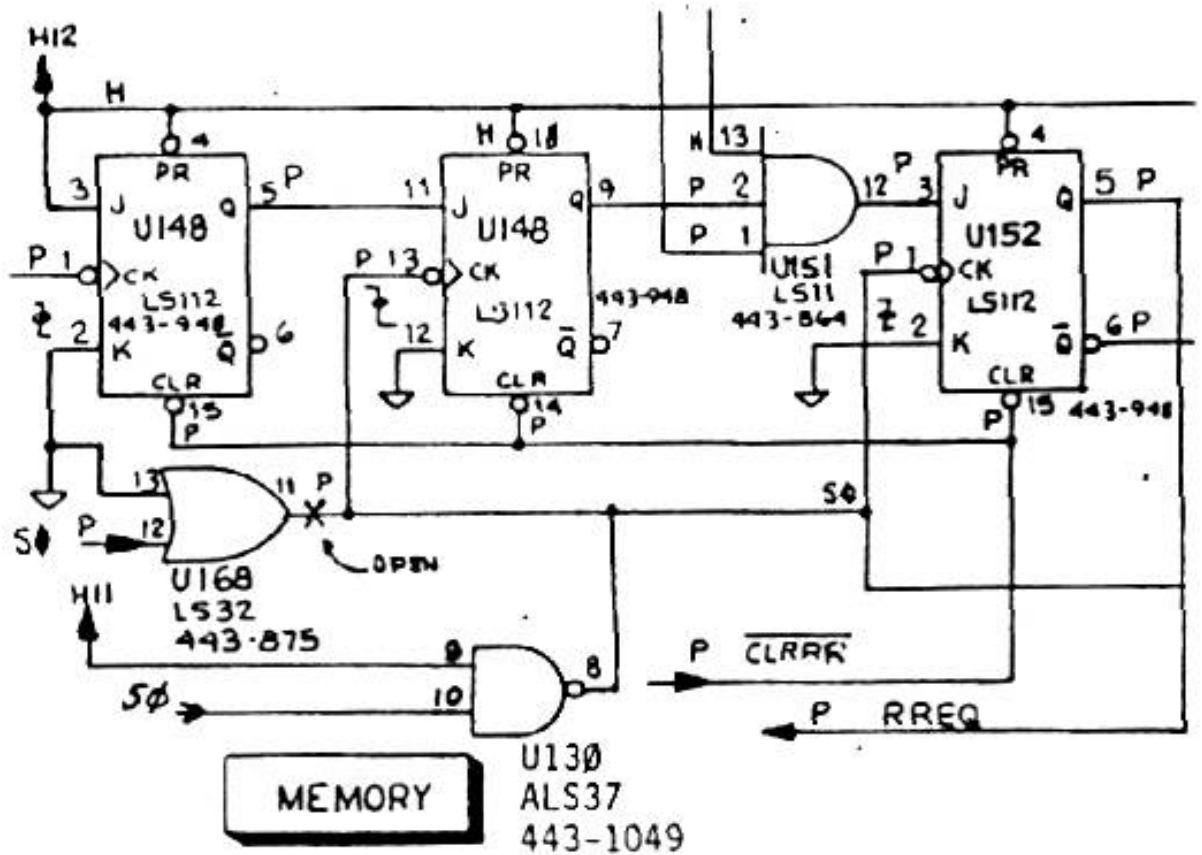
On newer versions of the Z-100 main board, HE 181-4106, 181-4507, 181-4920, 181-5743, and higher, a section of U130 (443-1049) is inserted into the Refresh Timing and Arbitration circuit. This section of U130 replaces a section of U168 used on the old main boards (HE 181-3630). To update your MB3 schematics, refer to the pictorial below and draw in the section of U130.
