HW-101 Refurb

How a Club Loaner Rig Becomes New Again.

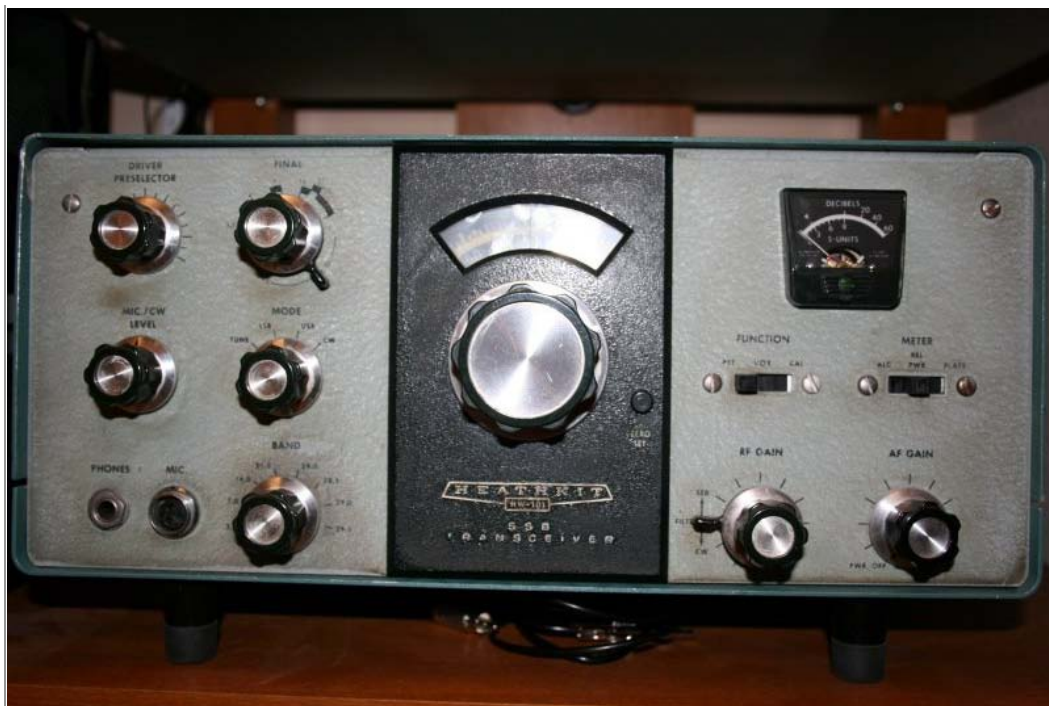
The front panel was dirty and worn from about 35 years of use and storage.

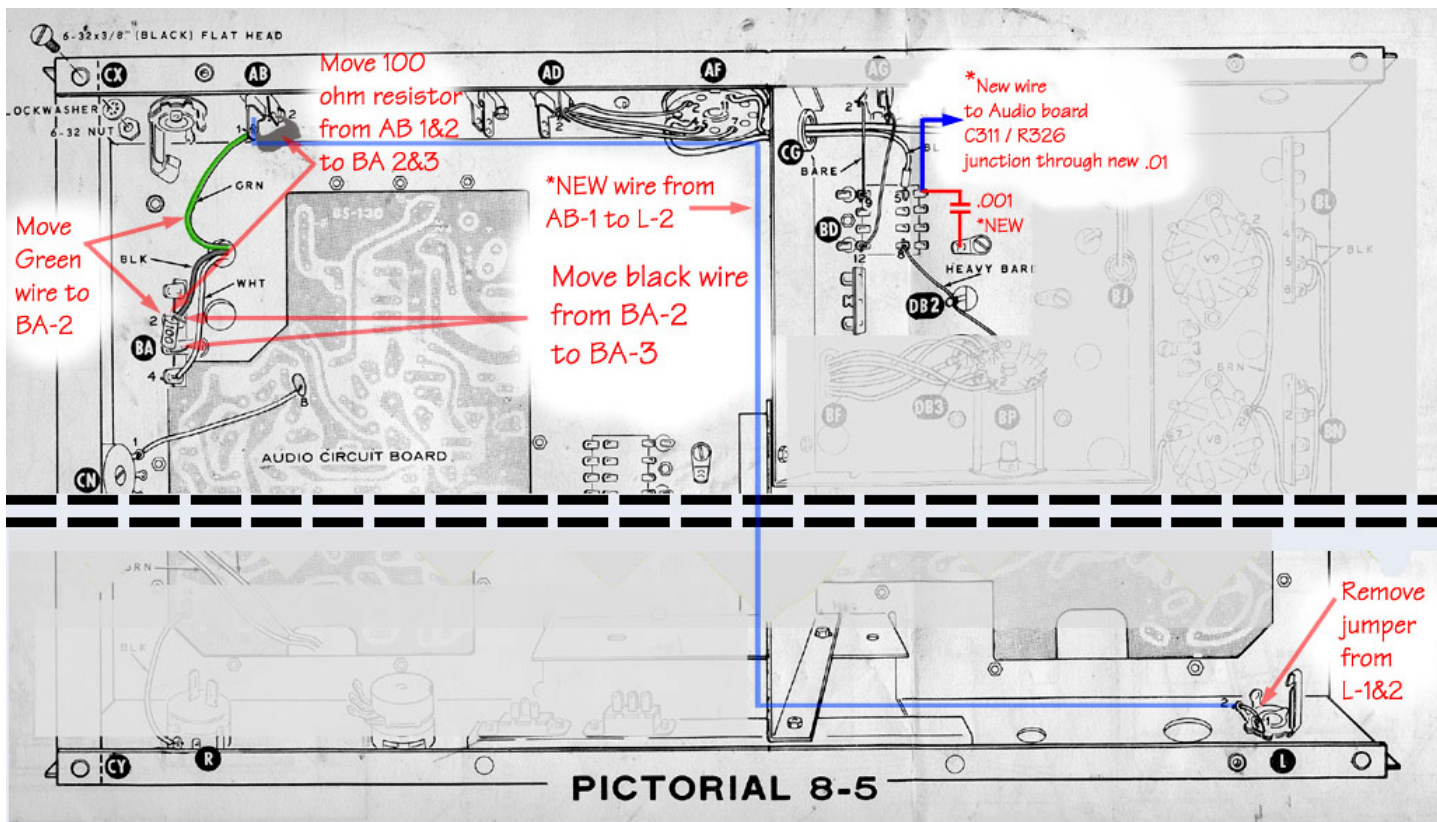
Figure 1

Another annoying problem with these rigs is the fact the sidetone can be heard when the rig is in the CW mode without the key actually being pressed. Although the sidetone amplifier is in deep cutoff, there is enough coupling through the inter-electrode capacitance of the tube to allow the output of the sidetone oscillator to be heard at a constant low level even when the key isn't being pressed. Fortunately this is also fairly easy to correct:

- 1) Connect a .001 μ fd disk capacitor (DO NOT use a higher value) from relay RL1 pin 1, to ground (**Figure 1**).
- 2) Connect a piece of wire about 8" long from pin 1 of RL1 and run this wire through the same opening in the shield as the wiring harness.
- 3) On the audio circuit board, replace 1M Ω resistor R326 with a 2.2M Ω resistor (**Figure 2**).
- 4) At the circuit board junction of R326 and C311, connect one side of a .005 μ fd 500v disk capacitor, and connect the other side of this capacitor to the wire from RL1 pin 1.

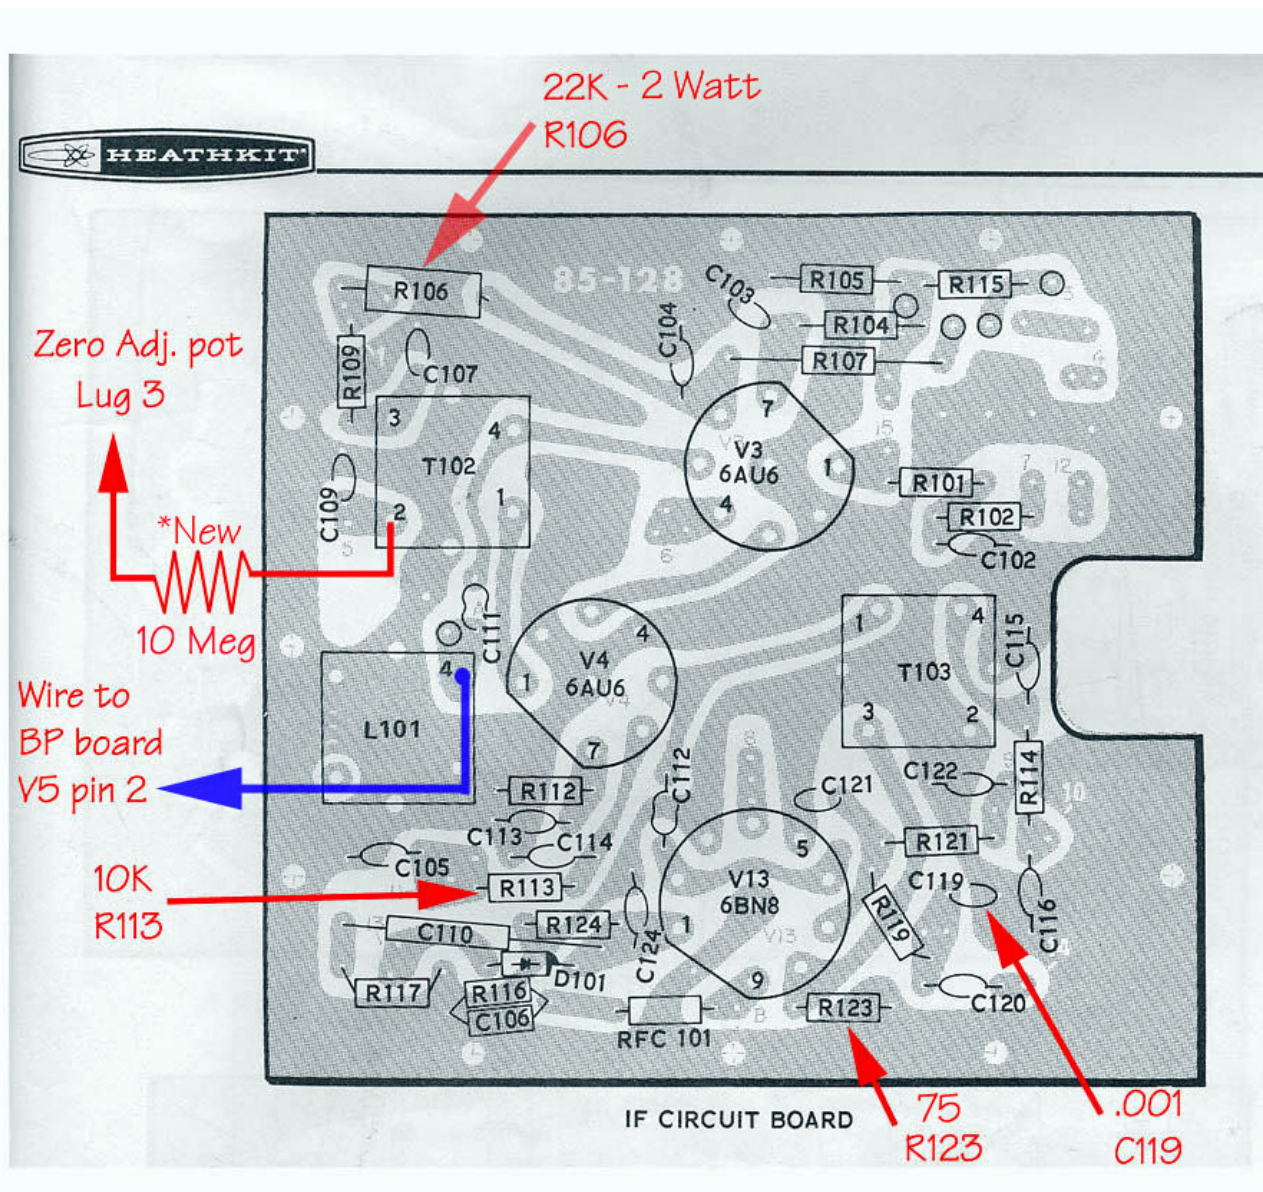
Figure 3

S-meter zero setting instability is mainly caused by heat-related resistance changes in the R106 22K Ω 1-watt resistor on the I.F. board. Replace R106 with a 22K Ω 2-watt wirewound (*Figure 3*).

To increase BFO drive, simply replace coupling capacitor C17 on the modulator board with a 100pf silver mica, and replace the 33K Ω resistors R6 and R7 on the modulator board with 27K Ω resistors (*Figure 4*). To reduce I.F. drive, change resistor R123 on the I.F. board from 470 Ω to 75 Ω (*Figure 3*).

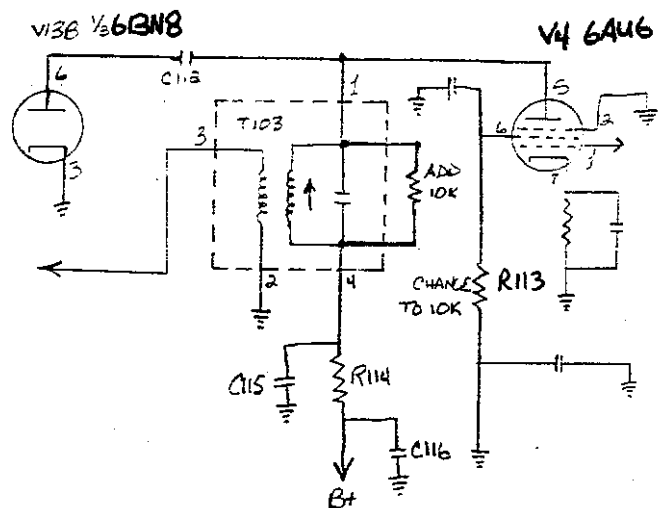
The screen voltage dropping resistor at V_4 (2nd i.f. amplifier) identified as R_{113} in fig. 1 is 1K, which seems too low and should be changed to 10K $\frac{1}{2}$ watt. This improves the operation of the i.f. chain somewhat in that it lowers the gain some, bringing about better product detector action and a lower heat dissipation at V_4 , thus avoiding its early failure. The overall gain may still be too high and can be lowered further as will be seen later.

Fig. 1—Changes to the second i.f. amplifier stage, V_4 , reduce overall gain of the HW-101 to useable levels and make S9 meter readings 50 μ v.
