HW-101 Refurb

How a Club Loaner Rig Becomes New Again.

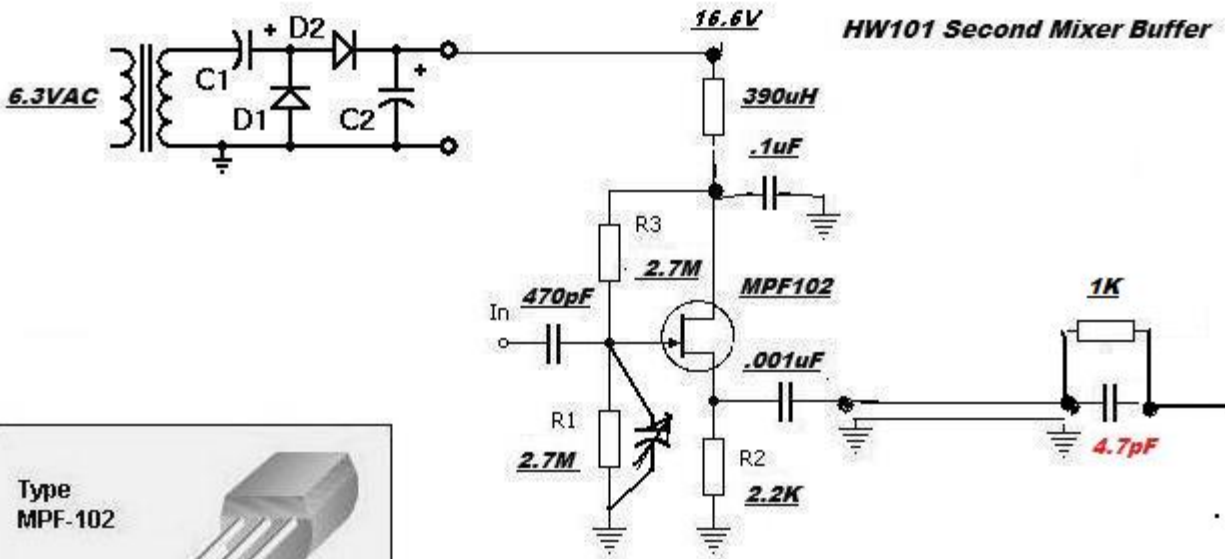
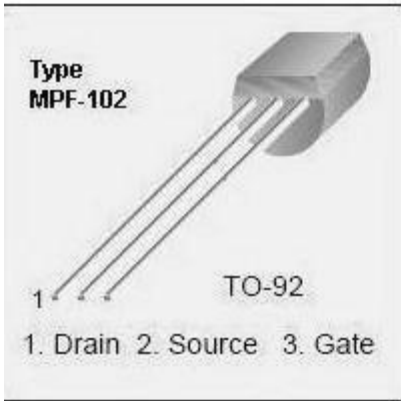
This circuit matches the crystal filter impedance of 2K to the high impedance output of the Second mixer.

Adjust 15-120pF C across R1 to allow tuning of mixer output LC. (Replaces coax capacitance)

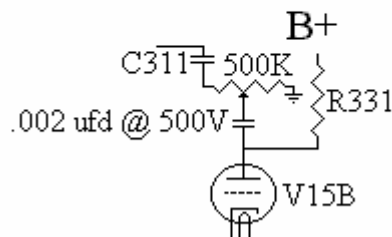
New Circuit

5. I recommend one examine the two excerpts from the schematic and the figure on page 189. A volume control for the side tone level on the SB-101 was provided. However, Heath didn't do this on the HW101. The SB-101 and HW101 use the same circuit boards so this is a real easy mod as the hole and terminals are already provided for mounting the pot.

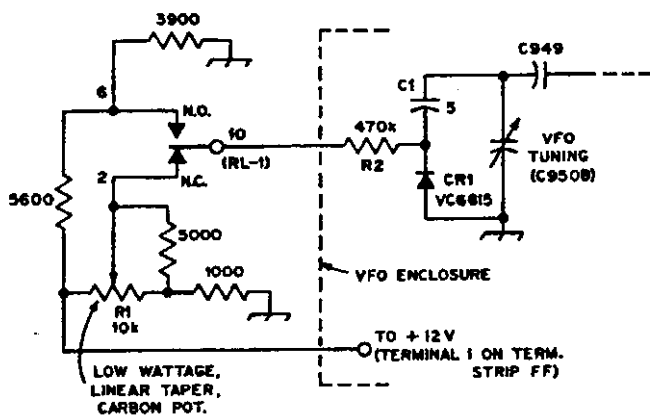
RIT for the HW-101.

CR1 is made by Eastron Corp., 25 Locust Street, Haverhill, MA 01830. This diode offers a capacitance range of 7.5 to 35 pF over a bias range of 0 to 20 volts. The diode is installed in parallel with the transceiver VFO tuning capacitor. If your transceiver offers only a negative dc voltage within the VFO, simply reverse the diode polarity in the circuit. The diode remains in the circuit at all times. A fixed value of bias is applied to the diode on transmit to provide a reference capacitance around which the receive-mode capacitance is varied. The bias is varied by R1 on receive, thus changing the VFO frequency. R2 serves as a

decoupling resistor to prevent the oscillator from being loaded down by the dc source. C1 isolates the dc from the oscillator tank circuit. With the resistances shown, a total change of about 4 kHz is realized over the range of R1. If you substitute different values for any of the resistors, make sure the transmit frequency is not varied accidentally when R1 is adjusted.
